**Review, Analysis and Opinion of the U.S. Department of Justice Expert  
Team Report, Duarte Nursery, Inc. US Army Corps of Engineers/  
United States v Duarte Nursery, Inc. et al**

Prepared for John Duarte, Duarte Nursery, Inc.

Sidney W. Davis, CPSS; David W. Smith; and Alan J. Busacca, Ph.D., CPSS, RG

March 2019

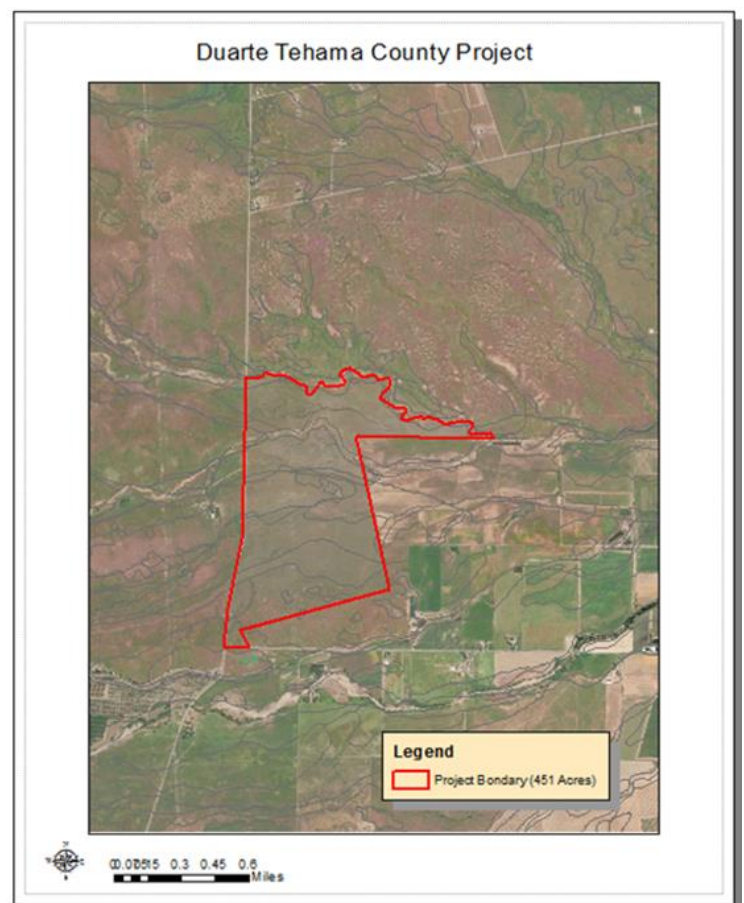
Figure 1 - Duarte Site Boundary

A 451-acre field that we will refer to in this report as the “Duarte Site” is located south of Coyote Creek and its intersection with Paskenta Road, about 5.2 airline miles southwest of Red Bluff in Tehama County, CA. The northern property boundary roughly follows Coyote Creek eastward from Paskenta Road, zigs back to the west, turns south and extends to the intersection of Dusty Way and Paskenta Road. From there it follows Paskenta Road northward to Coyote Creek along the site’s western boundary (Fig. 1).

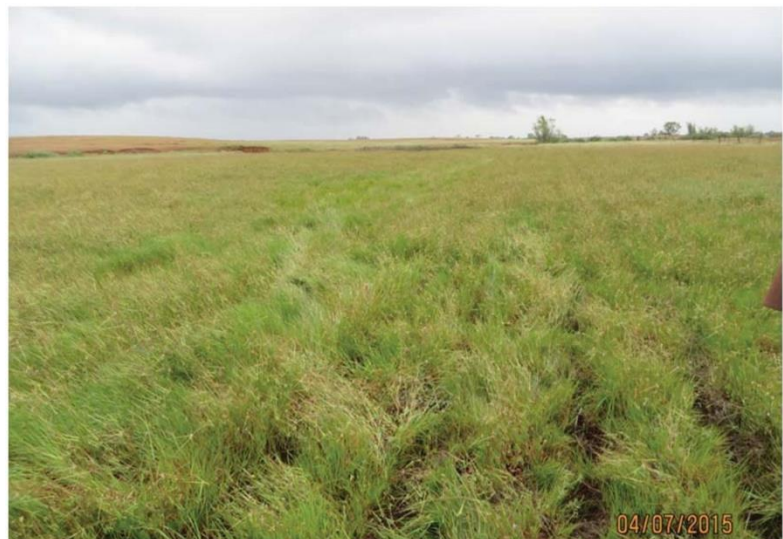
Figure 11 – An example of representative vegetative cover for assessing buffer continuity at Duarte Site in March 2015.

The ground level photo shown in Figure 11 was taken by the Expert Team on April 7, 2015 on the Duarte property (Photo F19, Appendix F). Their report contains numerous other photos showing well established vegetation in 2015 as well. Their documentation verifies that the vegetation has recovered to greater than 0 to 25 percent cover overall on the Property. The wide difference in Buffer Continuity Variable scoring assigned between the areas by the DOJ Team seems entirely unjustified. We're left wondering about the Lee Team's scoring of this and other HGM analysis variables?

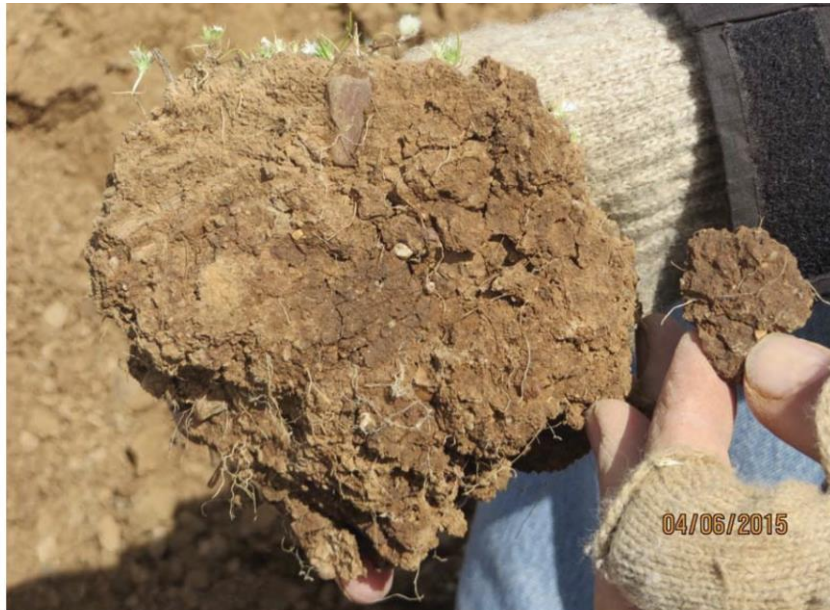
Figure 13 – Example of clay coated peds with 2.5YR or 5YR Munsell hues that the Team of Experts failed to record.

Photo F41. Mixed soil horizons due to tillage at Location 18 showing a thin veneer of sediment (3mm) and fragments of subsurface horizons present in the surface horizon.

Photo F41 from DOJ Appendix F (shown as our Figure 13) is of the surface horizon from site 18 and the caption says, verbatim: "Photo F41. Mixed soil horizons due to tillage at Location 18 showing a thin veneer of sediment (3mm) and fragments of subsurface horizons present in the surface horizon." Yet the official record of the observations of the soil scientist on the Expert Team, the WDDF soil description of Site 18, fails to record any of this critical information about the character of the surface horizon, or of any mixing, or of fragments of material from deeper horizons in that sample, instead simply ascribing a single matrix color and 2 colors asserted to be simply of redoximorphic concentrations.

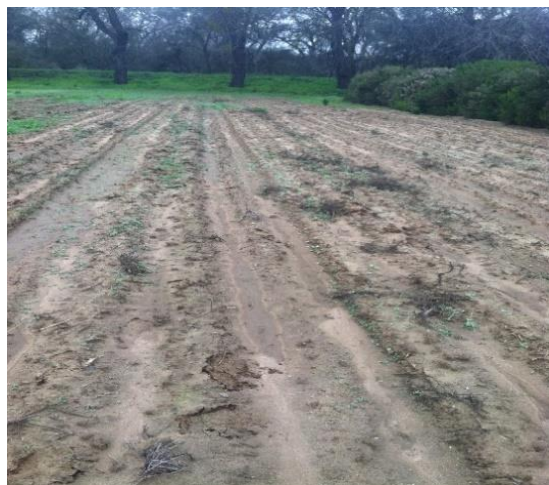
Figure 15 – An example of conventional tillage after rain storms.

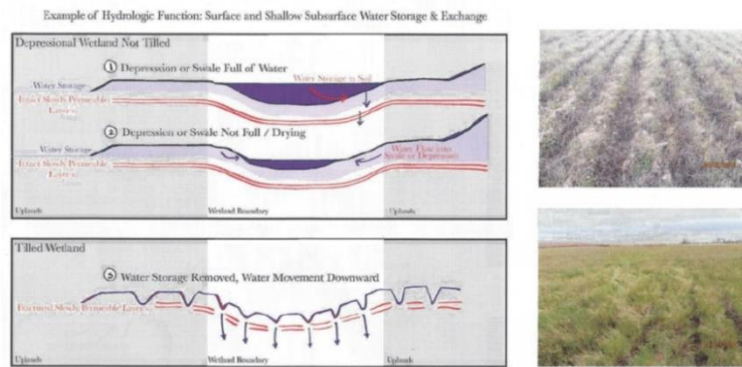
Figure 37. Schematic showing the impact of tillage across a depression or swale where the underlying slowly permeable soil layers are fractured. Water then moves downward in the soil profile rather than saturating surface soils, ponding on surface soils, or running off. The downward movement of water caused by tillage constitutes a significant change in the patterns of water flow and circulation within the depression or swale wetland. (Not to scale)

Figure 16 – Lee Report graphic illustrating water removal (unsubstantiated).

Figure 37 in the Lee Report (our Figure 16 shown here), is misleading: it suggests shallow tillage of the surface soil with tillage equipment will damage or destroy a restrictive subsoil horizon, making the soil more permeable. If that were true, the site would become less erosive, as infiltration would increase, runoff would decrease, and water quality would improve. That effect would be loss of wetlands. The soil
