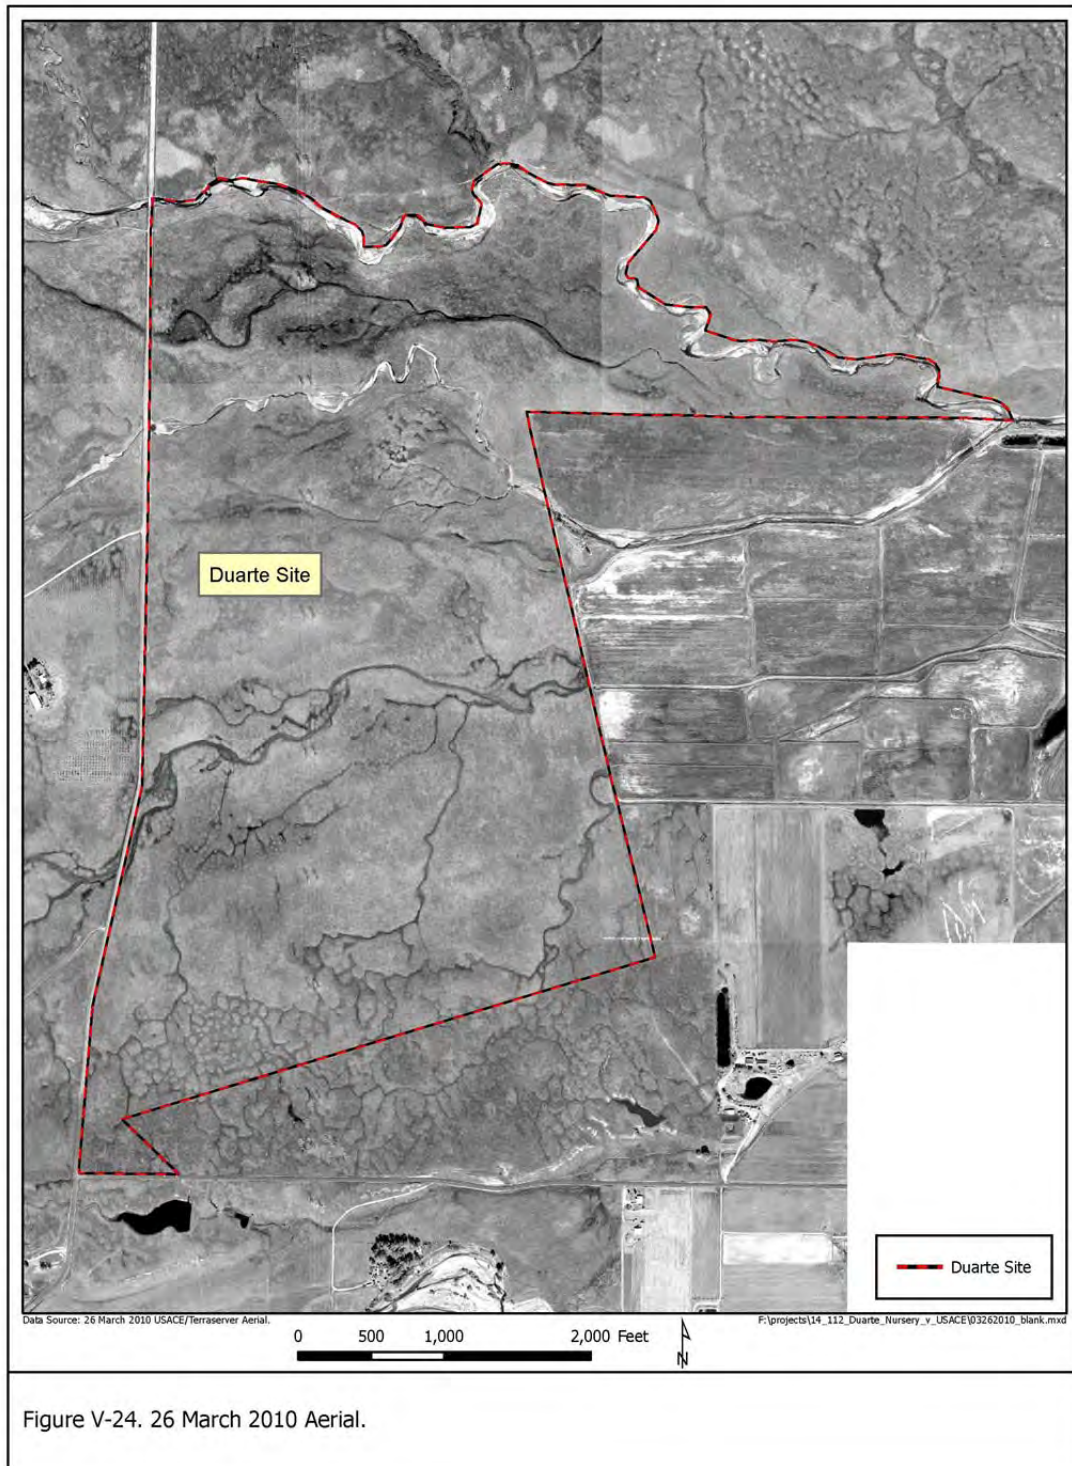
The “North State” delineation (Figure V-25) shows their interpretation of the distribution of 35.9 acres of waters/wetlands on the Duarte Site in 1994 (North State, 1994). This delineation was verified by the U.S Army Corps of Engineers October 26, 1994, (Bates # USA-NSR-00130-00131 and USA-NSR-00147-00148).

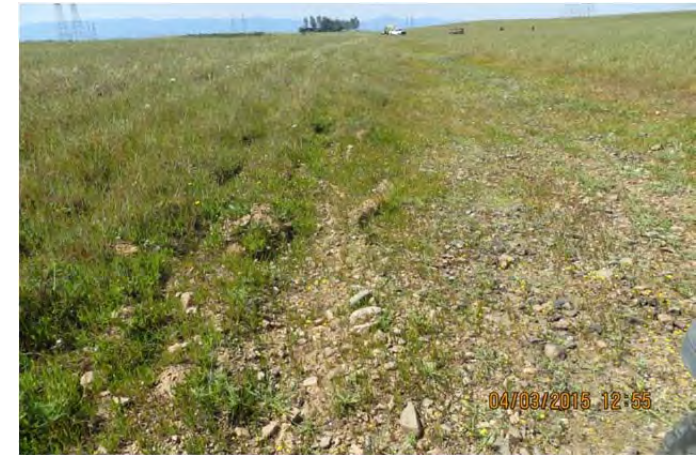
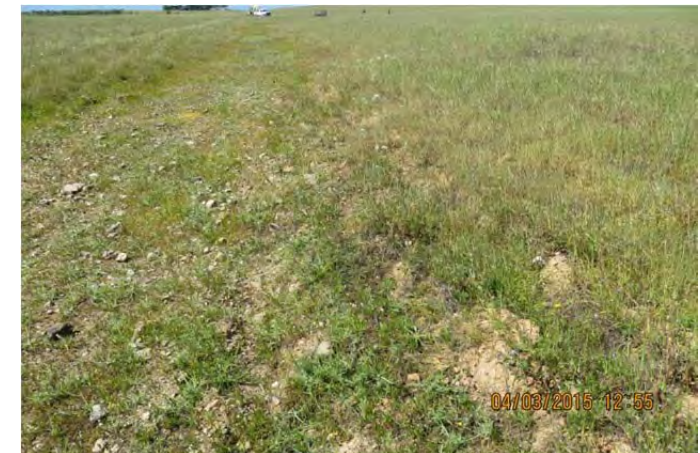
Figure V-38. Schematic of soil chunks or clods being dragged from the upland and deposited in the wetland. Upper photo shows deposition of upland soil in the wetland and lower photo shows upland soil chunks or clods that have been moved into wetlands. (Not to scale)

The DOJ Expert Team also noted was the dragging or side-casting of soil clumps or linear blocks or slabs of soil from adjacent uplands into waters/wetlands at some locations. Also, as a result of undulating terrain, the depth of tillage/ripping will vary and may exceed the observed range of 7 to 14 inches. This type of impact is depicted in the schematics of Figures 38 and 39.

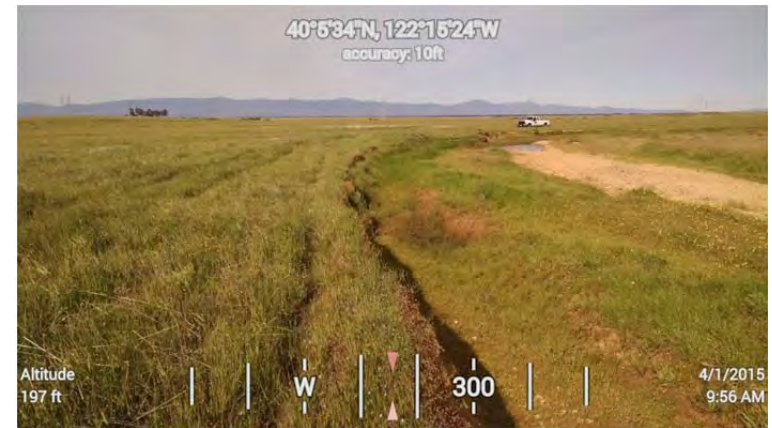
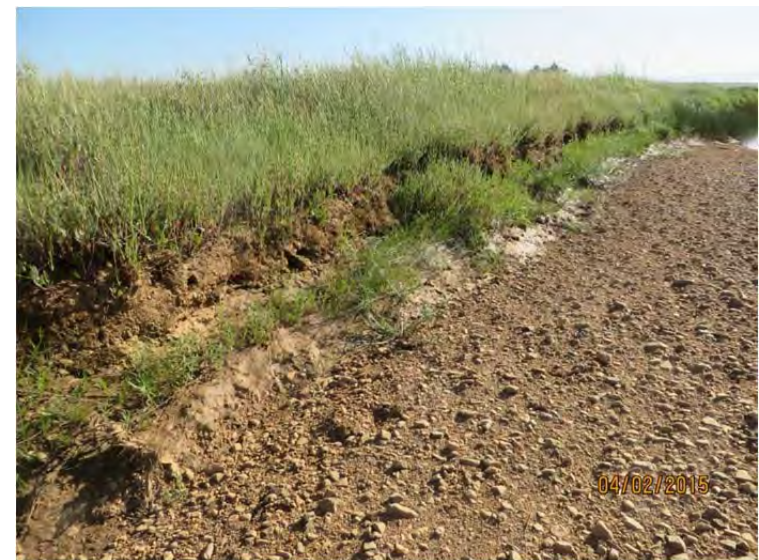
Figure V-39. Redistribution and deposition of soil slabs loosened by the tillage operation too close to the wetland edge. The upper photo shows tillage along the bank of the stream and lower photo shows the collapse of the loosened slab into the stream channel. (Not to scale)

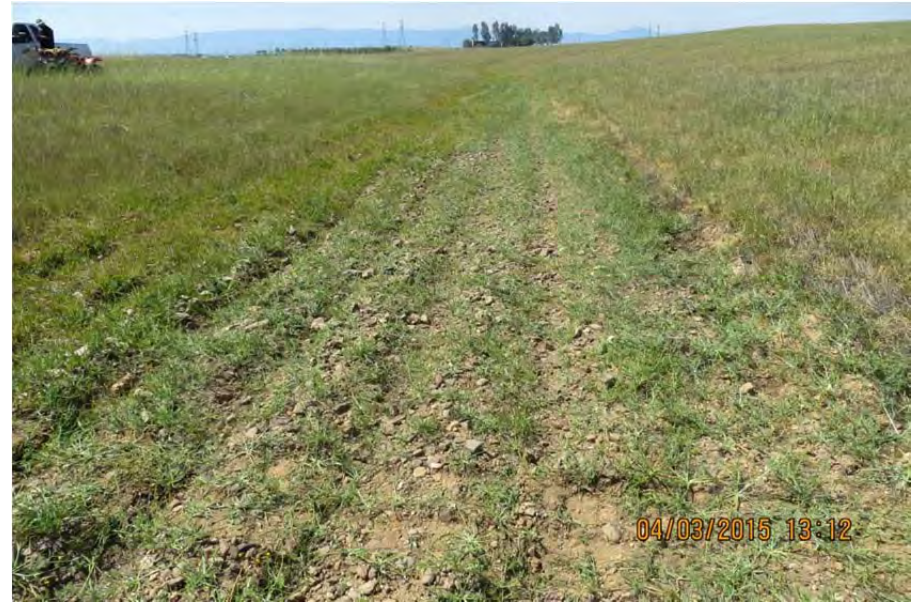
Figure V-43. Schematic of how predominate direction and timing of water movement is changed by tillage and associated piercing or fracturing of slowly permeable soil layers. (Not to scale)

Cumulative impacts to waters/wetlands on the Duarte Site occurred and continue to occur as a result of the soil surface and subsurface alterations that change infiltration, percolation, and permeability. These changes trigger significant and discernable alterations in patterns of water flow and circulation at the landscape scale. Specifically, these changes include significant alterations of on-site and landscape scale water balance(s), and water residence and turnover time(s) within complexes of waters/wetlands and in down gradient reaches of associated riverine ecosystems. Additional impacts at the landscape scale include fragmentation and timing of hydrologic connectivity to other waters/wetlands and surrounding areas, fragmentation/alteration of waters/wetlands patch size and the mobilization of sediment and deposition down gradient. All of which will affect the timing and delivery of water and compounds to down-gradient waters/wetlands, including the Sacramento River.

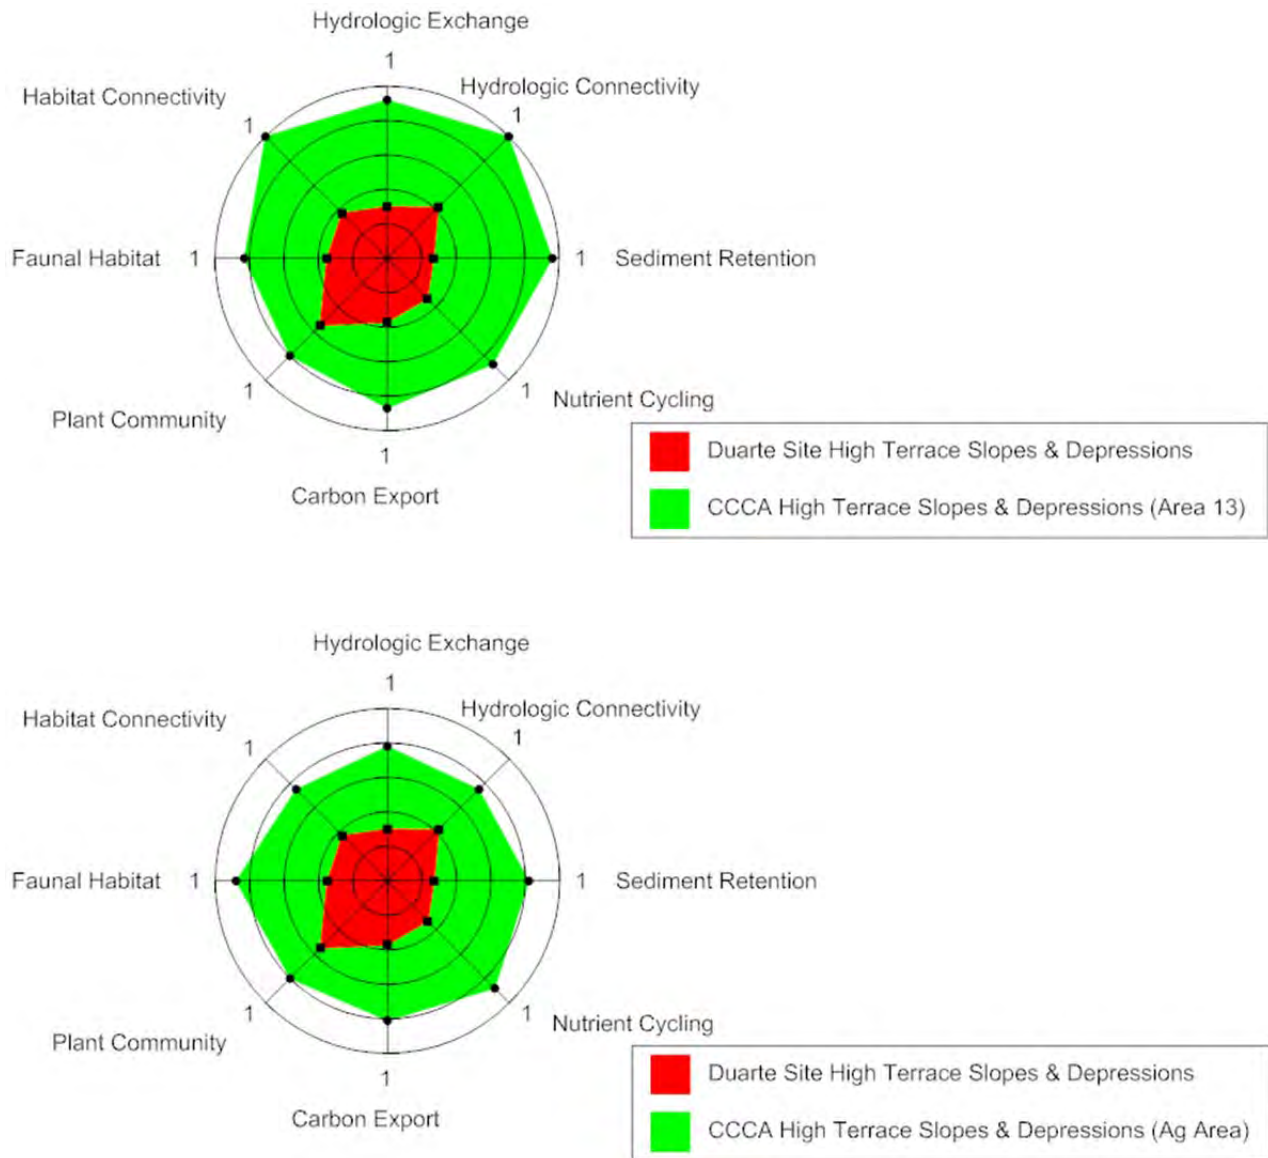
Figure V-44. Polar plots of the suite of Hydrogeomorphic wetland functions for the Duarte site post disturbance compared to the CCCA for high terrace slopes and depressors.

The import of the HGM functional assessments summarized in Figures V-44 through V-46 is that, considered as connected and similarly situated landscape units, the depressional, swale, and stream ecosystems that exist on the Duarte Site post Late Fall of 2012 are significantly degraded with respect to their physical, biogeochemical, and biological structure and functioning. When aggregated and because the Duarte Site waters/wetlands are connected along a river continuum (Vannote et al., 1980) the degraded functioning of these headwater waters/wetland ecosystems will negatively impact the physical, chemical and biological integrity downstream reaches of the Coyote/Oat Creek systems and the traditional navigable waters of the Sacramento River.

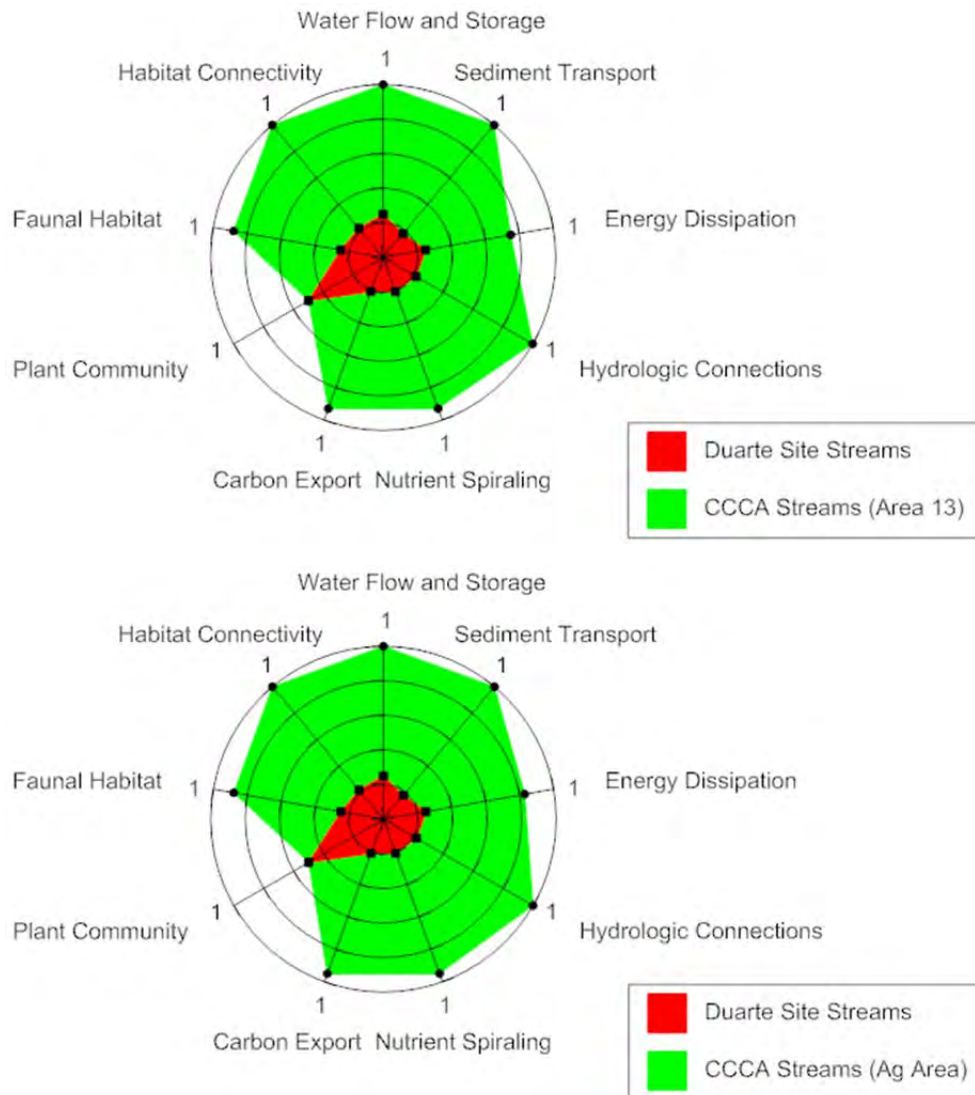
Figure V-45. Polar plots of the suite of Hydrogeomorphic wetland functions for the Duarte site post disturbance compared to the CCCA for streams.

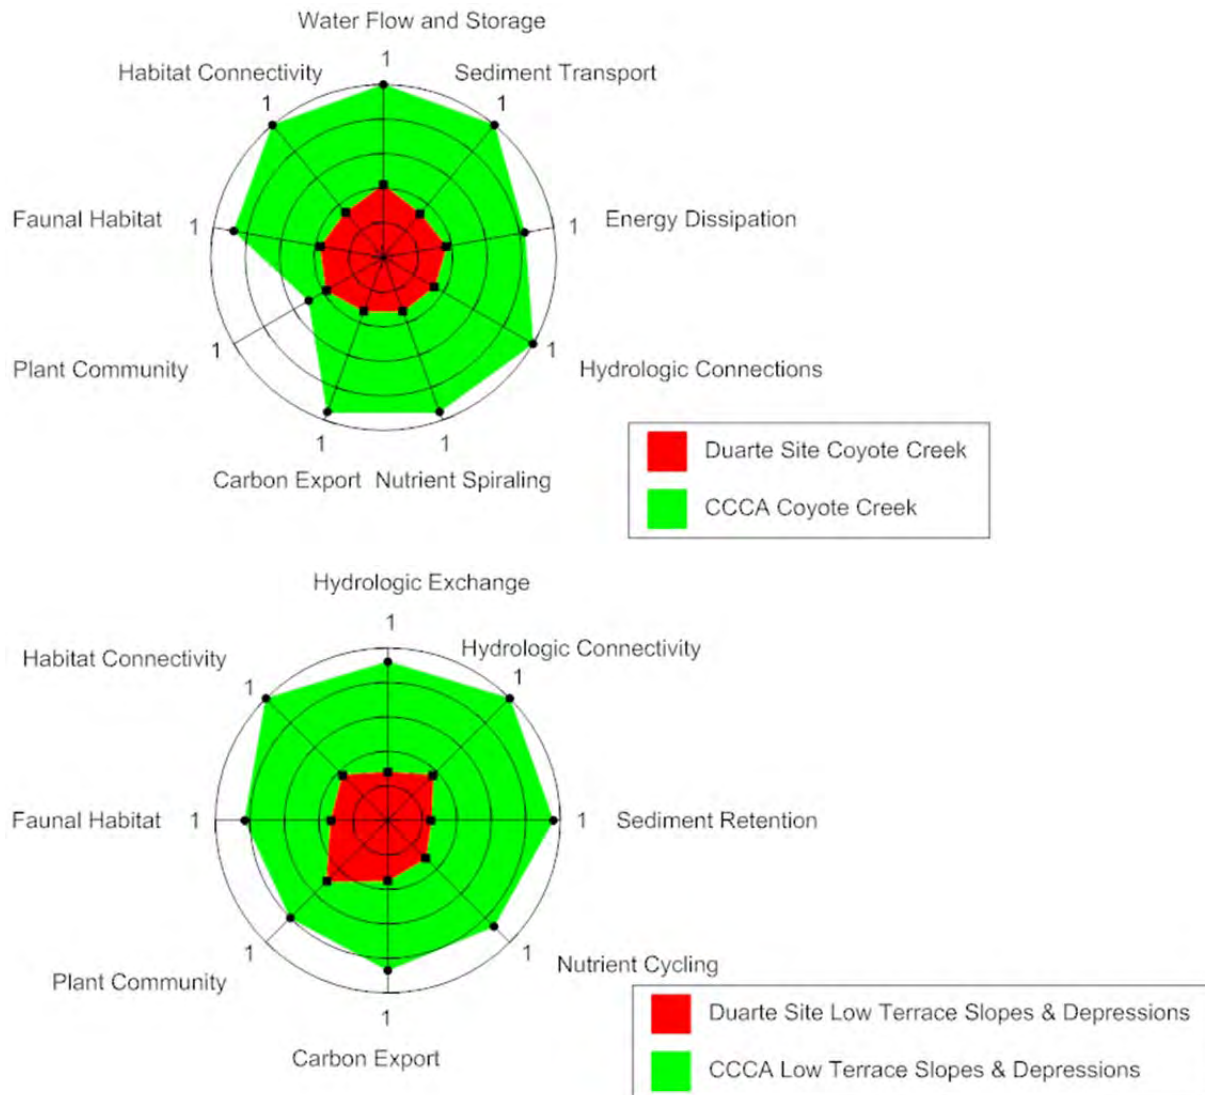
Figure V-46. Polar plots of the suite of Hydrogeomorphic wetland functions for the Duarte site post disturbance compared to the CCCA for low terrace slopes and depressions.
